ANALYSIS OF A STRUCTURAL ADHESIVE DETACHMENT

CUSTOMER CASE STUDY

Author: Benjamin Bussenniers

AUGUST 2025

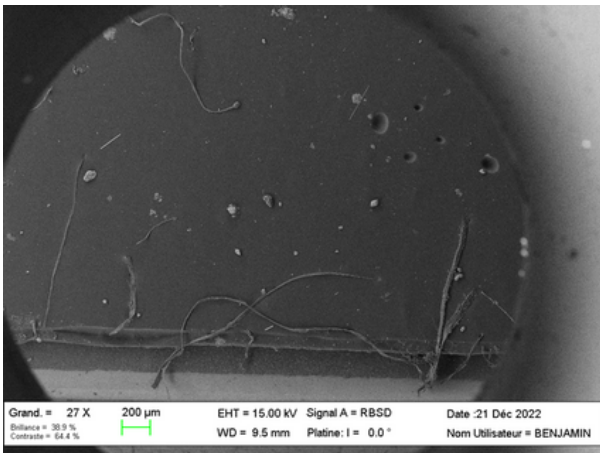
Many particles could be observed and identified (see Figure 1): gypsum, cardboard, hair... nothing unexpected for a sample that spent some time in a normal environment, attached to a normal wall.

More precisely, we could not determine whether the particles were partly responsible for the adhesion failure, or whether they were symptoms, adhering to the adhesive after it detached from the housing.

Figure 1: Adhesive detached at a customer site, sample 1 (SEM imaging).

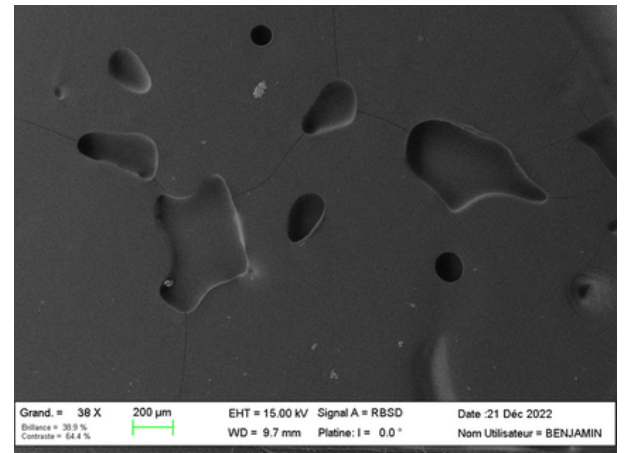
Figure 2: Adhesive detachment at requester site, sample 2 (SEM imaging).

Sample 2 also showed adhesion failure between the acrylate foam and the ABS housing, but was never sent to a customer, because the requester noticed the poor adhesion. It was slightly cleaner (see Figure 2) but showed a similar variety of particles: mineral dust, gypsum, cardboard and hair.

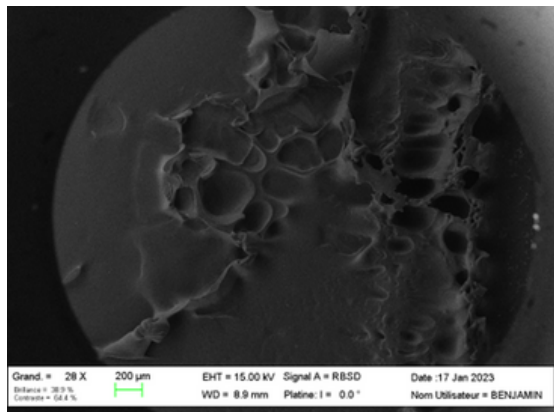
Samples 3 and 4 (next page) were kept at the manufacturer and show no adhesion problems. Furthermore, the acrylate foam shows more intense stretching structures (see Figure 3) after being detached in the laboratory. It is nevertheless possible that these structures resorbed or were flattened after their formation for the detached samples. At this stage, we cannot draw conclusions.

Figure 3: Sample 3, different supplier, no sign of detachment (SEM imaging).

- No unexpected contaminants.
- The observed particles are rather omnipresent. Some of them might even have deposited on the sample in the laboratory.
- The stretching marks observed on sample 3, the "good sample," indicate better adhesion of this adhesive, assuming these marks do not resorb over time.

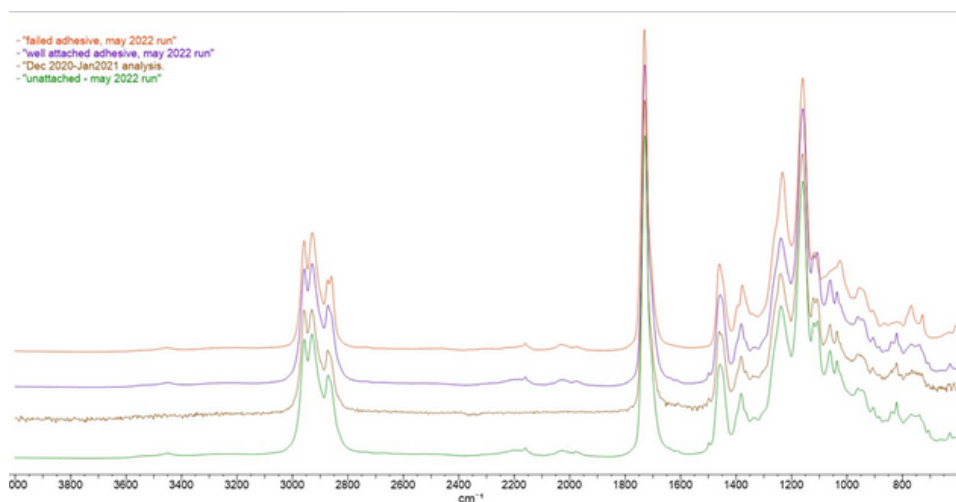
Figure 4: ATR-FTIR spectra of (from top to bottom): detached adhesive from sample 1 (orange), adhesive from sample 3 (violet), adhesive from a batch from the previous year (brown), adhesive from sample 4 (green).

Using our micro-ATR with Germanium, we collected spectra at the surface of various samples (see Figure 4). The general appearance of the spectra corresponds to what was expected: they are all acrylic polymers. However, slight differences exist between sample 1 and all the others, suggesting a probable difference in composition and/or relative abundance of side chains.

All adhesives with good adhesion, stable over time, are identical in terms of composition. The problematic adhesive from samples 1 and 2 appears to also be a polyacrylate, but with different side chains.

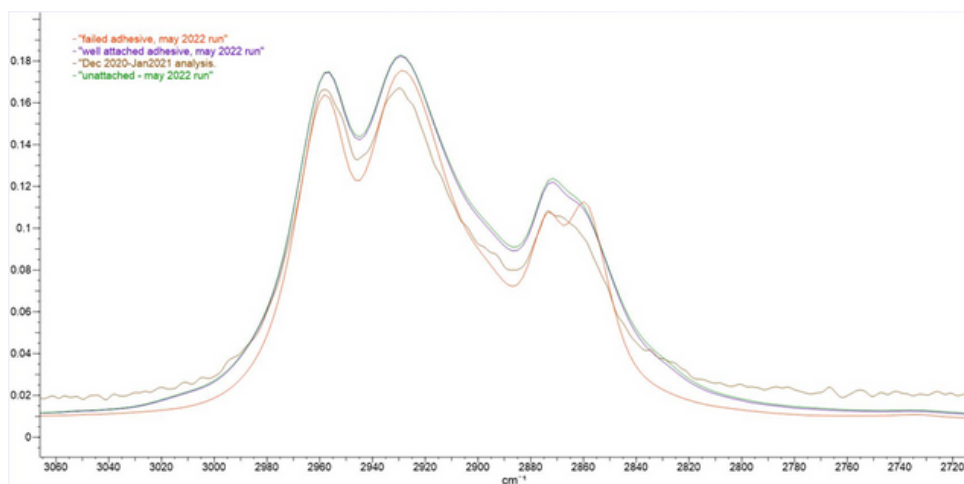
- By looking at the peaks around 2850-2880 cm^{-1} , we observe a more marked separation in our problematic sample (see Figure 5).
- The peak around 1230 cm^{-1} is higher for our problematic sample and slightly shifted toward lower wavenumbers (see Figure 6).
- The peaks between 1150 cm^{-1} and 1000 cm^{-1} are very different for our problematic sample (see Figure 6).
- There is no peak at 820 cm^{-1} , and two peaks at 770 and 730 cm^{-1} (see Figure 6).

Figure 5: Hydrocarbon region. The spectra have been normalized to facilitate comparison. Detached adhesive from sample 1 (orange), adhesive from sample 3 (violet), adhesive from a batch from the previous year (brown), adhesive from sample 4 (green).

If we consider the peaks around 2860 cm^{-1} and the presence of two small peaks around 750 cm^{-1} , this could indicate that our problematic acrylate has longer hydrocarbon side chains.

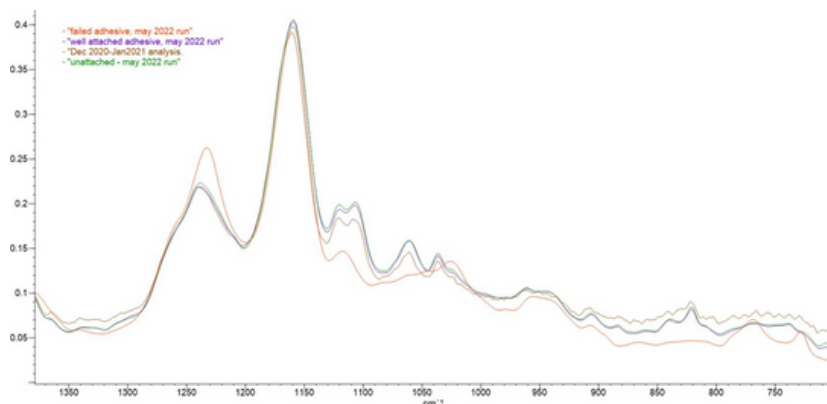
The absence of distinct peaks between 1150 and 1000 cm^{-1} in our problematic sample could indicate that the C-O bonds are less varied, so that the composition and/or proportion of side chains could be different, but this is more hypothesis than conclusion.

Figure 6: "Fingerprint" region. The spectra have been normalized to facilitate comparison. Detached adhesive from sample 1 (orange), adhesive from sample 3 (violet), adhesive from a batch from the previous year (brown), adhesive from sample 4 (green).

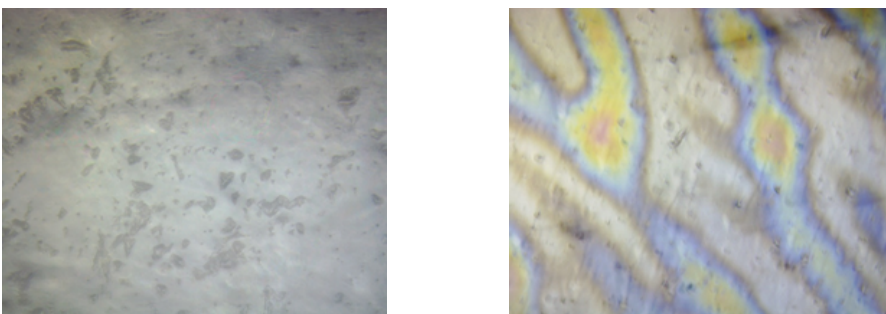
For the protective films, the situation was quite different. Verified by ATR-FTIR, supplier B's original protective film consisted of a PE (polyethylene) sheet covered with a thick white non-adhesive PDMS (polydimethylsiloxane) layer providing good coverage. The PDMS layer showed some imperfections, but nothing major (see Figure 7). Supplier A's second protective film was, let's say, of inferior quality. The PDMS layer is so thin that it causes the iridescent effect visible in Figure 7, right.

Figure 7: Inner face of protective films, on the adhesive side. Left: supplier B's original protective film, covered with a thick, relatively uniform PDMS layer. The PE core sheet is barely visible in the holes of the PDMS layer. Right: supplier A's second protective film. There is practically no PDMS, the PET core sheet is detectable everywhere.

It is certain that removing the protective film long before the adhesive is attached to the housing is not good practice. Installing another protective film of lower quality is also not good practice.

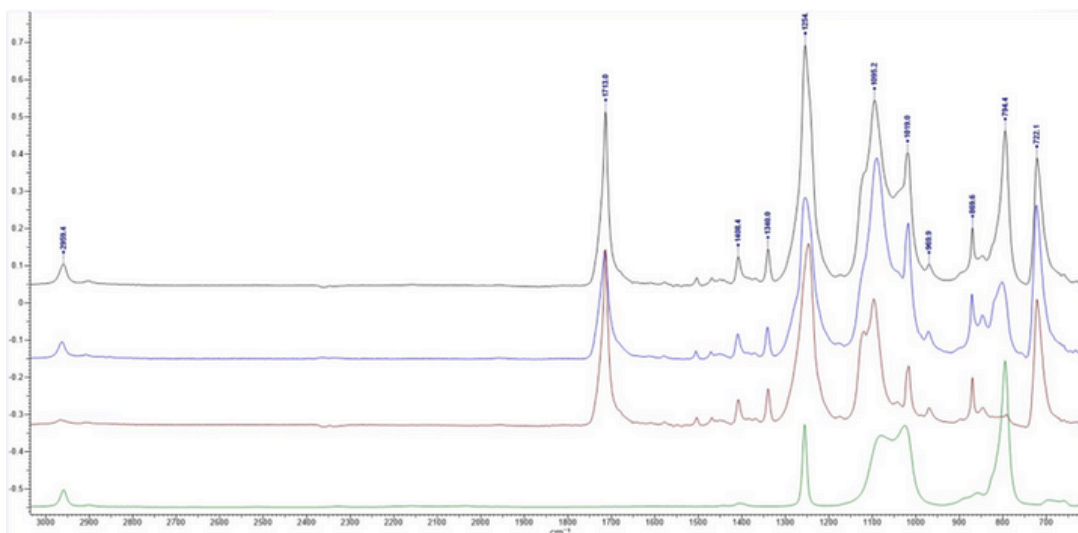
As shown in Figure 8 below, the PDMS signal is generally weak, sometimes almost non-existent. The simplest way to track the presence of PDMS in this sample is to observe the Si-C peak around 795 cm^{-1} ; it is barely visible in the brown spectrum, indicating that it represents about 10% of the signal. Generally (with exceptions), a composition difference of less than 5% will be (very) difficult to detect by FTIR.

Figure 8: ATR-FTIR spectra of supplier A's protective film. Black: Reconstruction of a PDMS and PET mixture spectrum. Blue: spectrum acquired in the blue zone of Figure 7 (right). Brown: spectrum acquired in the brown zone of Figure 7 (right). Green: generic PDMS spectrum.

This second protective film will therefore not be very effective, as the PDMS layer, which is responsible for covering the acrylate with the least possible interactions, is very thin. We did not investigate whether there were actual holes in this layer, but we can already observe the large variance in this layer's thickness, so it's not impossible. Could the acrylate foam adhere to the PET (polyethylene terephthalate) core in places? It's possible.
